Hitchin Footpath Problems – August 2016 Update

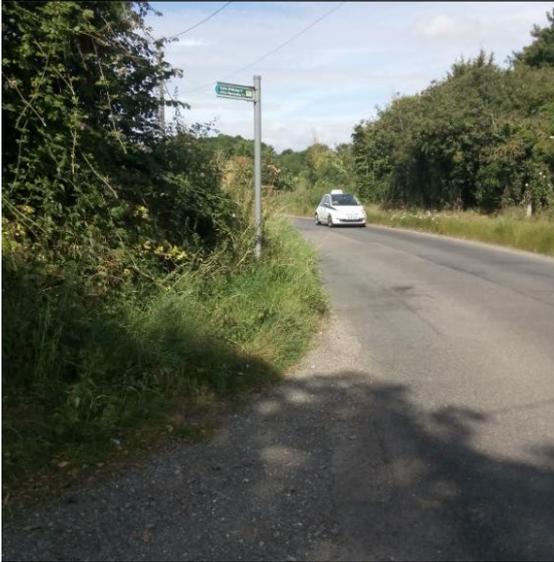
1. HOOP between Gypsy Lane (FP94) and Wymondley Road / St Michaels Road roundabout

Although the verge on the N side of the road was still passable when I checked on 30/7/16, the verge on the south side was overgrown and anybody emerging onto the road from BW Wymondley 6 would have a restricted view of traffic approaching from the Hitchin direction (see picture). The newly installed signpost near the St Michael's Road roundabout at the junction with FP81 is pointing in the opposite direction from that intended (see picture).

Restricted view towards Hitchin from BW Wymondley 6

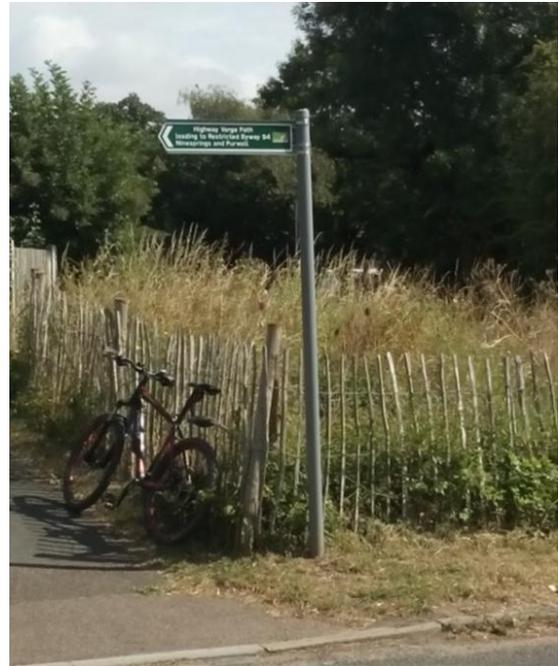
Signpost for verge path pointing in wrong direction

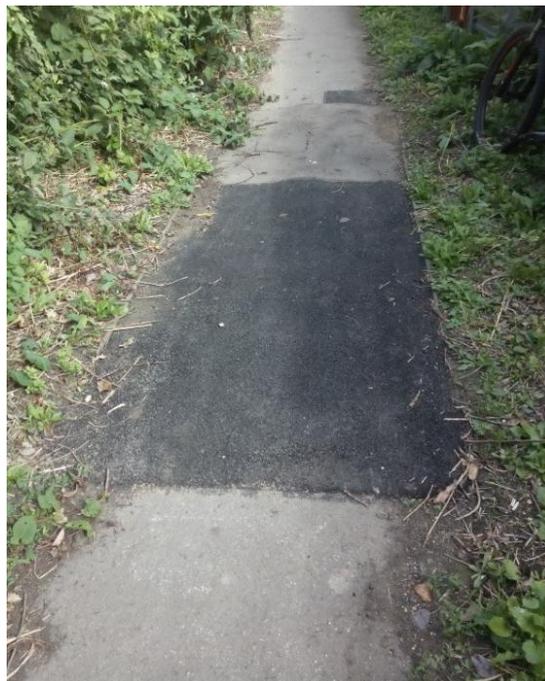
2. Footpath 10

A much better repair of the pothole has been made. Nevertheless, experience suggests that this will eventually fail so continued monitoring will be required.

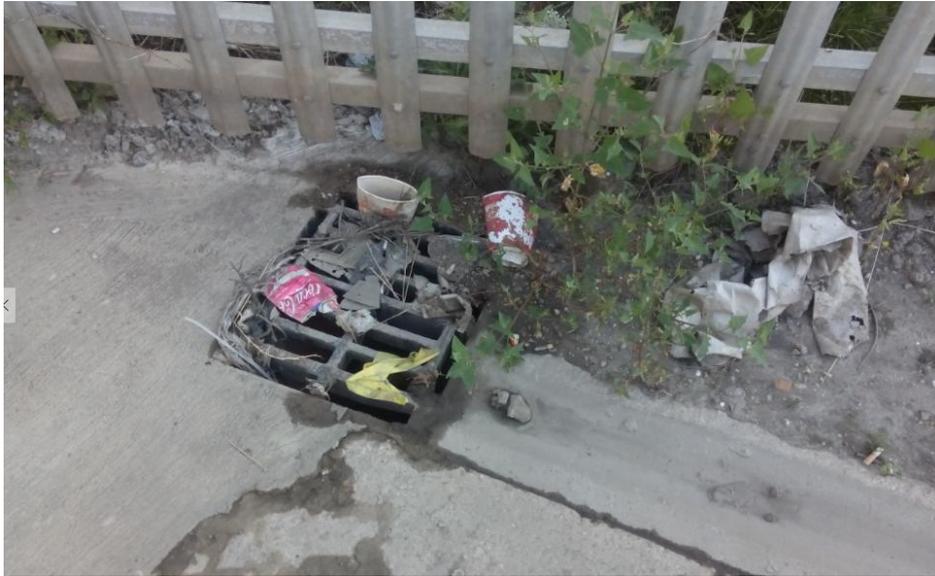
3. Footpath 26

The drainage problem appears to have been solved, although I visited after prolonged dry weather, so it was unclear if there had been a puddle in the preceding days. The new drain could easily be blocked in future by detritus and needs to be monitored.

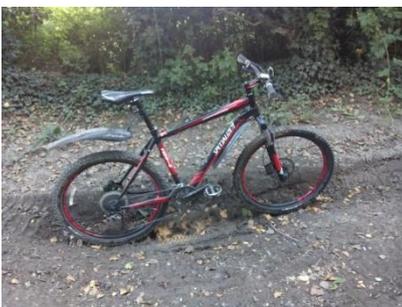
6. RB3 Oughtonhead Lane

There are now a number of potholes on the S side of the track that has recently been resurfaced between BW5 and FP2. They are as deep as they were before the work was carried out – see the picture showing the mountain bike for scale – the track surface is at the level of the wheel hubs, so the hole is at least 30cm deep and about 1.5m in length. As noted previously, although not a problem to walkers at present, the holes will continue to grow. In wet weather, they would be a hazard to unsuspecting mountain bikers and horse riders

Whether it is a good use of resources to attempt to address this issue is now open to question. The potholes on this level section of RB3 are not inconsistent with the section of RB3 between the end of Redhill Road and the junction with BW5, although the nature of the hazard is different. This stony section of track is sloping, but cut by relatively deep gullies due to the passage of water, and would be challengingly uneven to anybody not a confident walker.

The path is also used illegally by trail bikers, especially in summer, as noted previously. In fact these may be partly responsible for the potholes. With several points of entry, this is a difficult problem to address, but potentially very serious – these bikes display no license plates and are unlikely to be insured. Their riders appear oblivious to the potential presence of young children on the track.

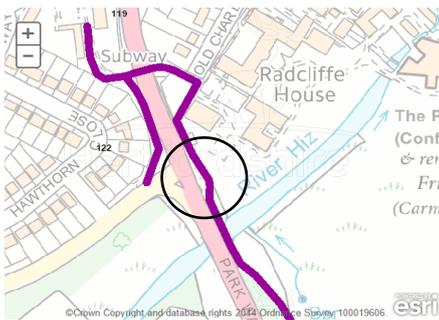
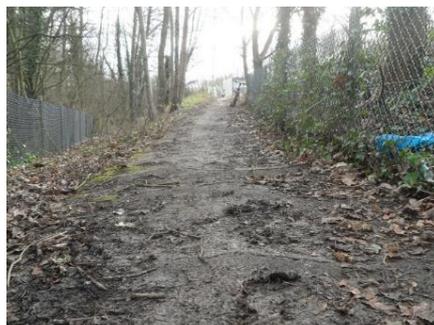
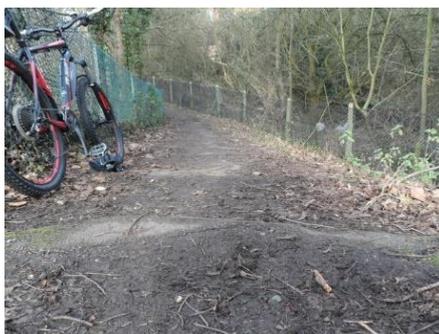
8. FP119 tree root damage

Uneven surface on the tarmac section between the end of Old Charlton Road and the bridge over the R. Hiz (see map below). An issue here is that after this section, heading towards the Three Moorhens, the path is unsurfaced – it can be muddy but is reasonably even. This tarmac section could be treacherous if covered with leaf litter. On 3/8/16, it had not deteriorated significantly since my last visit, and the only lasting solution would be to remove the trees which screen the path from the road and which I consider undesirable. I would suggest that no action is required.
