A bumpy ride – a summary of hazards encountered by wheelchair users during a journey to Hitchin town centre.

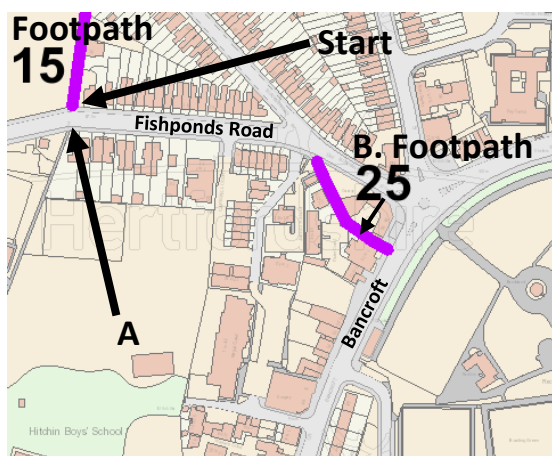
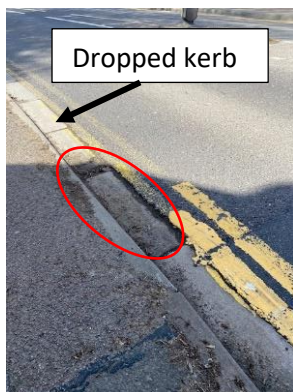
A. Fishponds Road (footpath 15 junction) to Bancroft

A. Our journey started at the southern end of footpath 15, where it meets the A505 Fishponds Road (see map above). There are dropped kerbs on both sides of the road and a refuge in the centre. Whilst the camber of the road causes no problems, the dropped kerb on the south side of Fishpond's Road has a sunken flagstone on its left hand side as the user approaches from the north (circled in picture). This has the same effect as increasing the camber - if Adrian does not keep to the right hand end of the ramp, the chair's footrest will catch on the kerb and Sharon will be tipped forward.

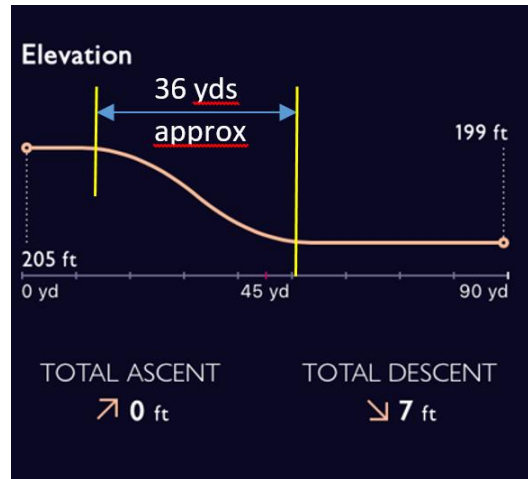
B. Footpath 25 falls 7ft (2.1m) in a total length of 90 yards (82m), which is an overall gradient of 1:39, conforming with guidance. However, the Ordnance Survey App shows the gradient profile of FP25 (right) revealing that the majority of the fall occurs in the middle section over a distance of approximately 36 yards (33m) giving a gradient of approximately 1:15 – steeper than recommended. Adrian choses to use FP25 because its surface is superior to the pavement passing in front of the car showroom on Fishpond’s Road. Both alternatives are better than the pavement on the north side of Fishpond’s Road alongside the Victoria pub, however, which is narrow, with a considerable crossfall towards the carriageway.

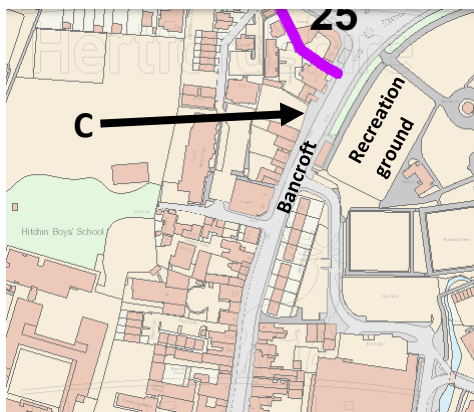
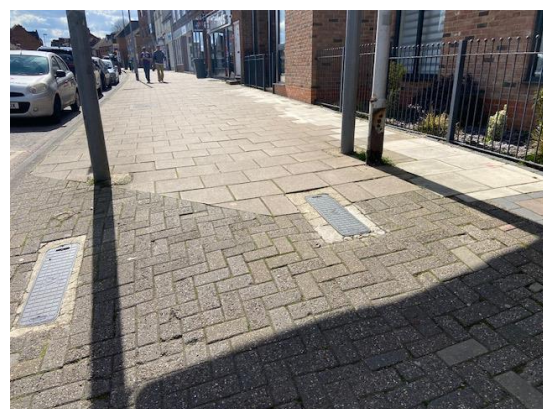
C. Vehicle Entrance to Parkview.

Almost all vehicle entrances present problems to the wheelchair user. Of those encountered on the route, the one leading into Parkview is the most difficult to manage. It consists of pavers, which are uneven because they are insufficiently supported by the base on which they are laid to cope with continuous vehicle use. There is a significant crossfall between the fence, which forms the boundary of the property, and the road surface in Bancroft. If the surface is icy, this represents a major hazard. At present, the crossfall gradient is slightly shallower closer to the building, so Adrian tries to take advantage of this, having then to either pass between the fence and the signpost support and redundant (lamp?) post, or between the supports. There

is a significant crossfall between the fence, which forms the boundary of the property, and the road surface in Bancroft. If the surface is icy, this represents a major hazard. At present, the crossfall gradient is slightly shallower closer to the building, so Adrian tries to take advantage of this, having then to either pass between the fence and the signpost support and redundant (lamp?) post, or between the supports. There

is no guarantee that the gradient profile will remain constant over time, so with continued deterioration, this may not be an option in future.

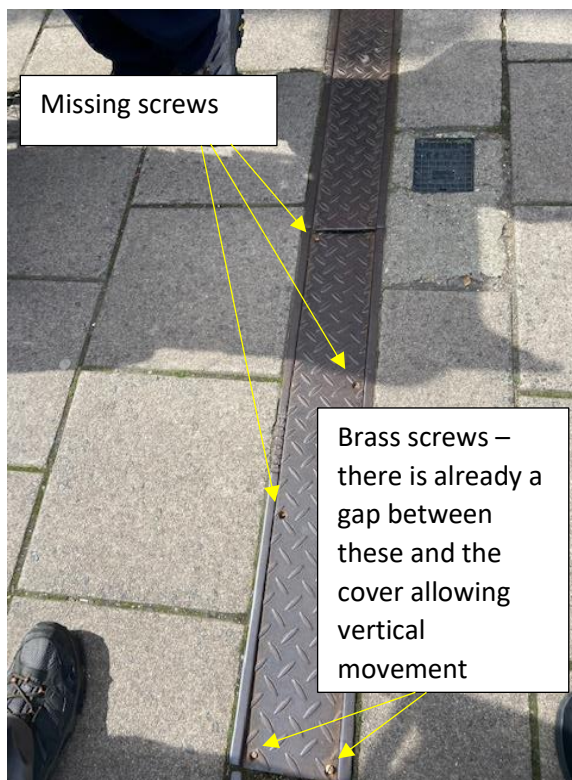
D1. Gully covers.

These are a regularly encountered hazard – many buildings have at least one. They appear to consist of a concealed black plastic pipe (due to damage, the pipe is visible in some cases) which is chased into a rectangular cross sectioned channel in the pavement which slopes down from the building to the road surface at the kerb. The purpose is to conduct rainwater

from a building's external drainpipe to the road surface. The covers often appear to be secured by countersunk brass screws. This system is guaranteed to have a short lifespan because, in wet conditions, the combination of brass with the steel cover accelerates erosion of the ironwork. Before long, the diameter of the hole exceeds that of the screw head, resulting in the cover being no longer secure and allowing it to move up and down. It can then deform under pressure so that it sticks up in some places and is dented in others. In the end, the cover will crack. Some covers have sunk to the extent that they have been covered with tarmac which has itself sunk. In some cases, damage has been exacerbated by pavement parking.

The effect is to create a surface which is uneven for a wheelchair occupant and a possible trip hazard for any user, but especially the attendant, whose view of immediate hazards is compromised as previously explained. If the cover has sunk significantly, the small diameter front wheels of a wheelchair can catch in the dip, throwing the occupant of the chair forward, and likely causing injury to the attendant.

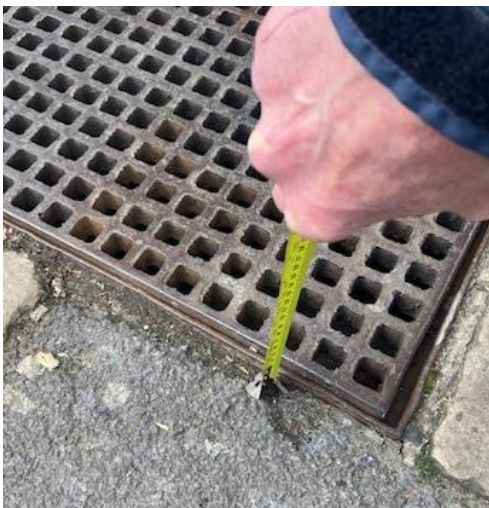
D2. Inspection chamber covers.

There are a number of inspection covers throughout this section of the route and not all are flush with the surrounding pavement. In the picture to the left, the surface of the grill is about 15-20mm above the surrounding tarmac and pavers. Steel grills and covers like the one shown can be slippery in wet conditions.

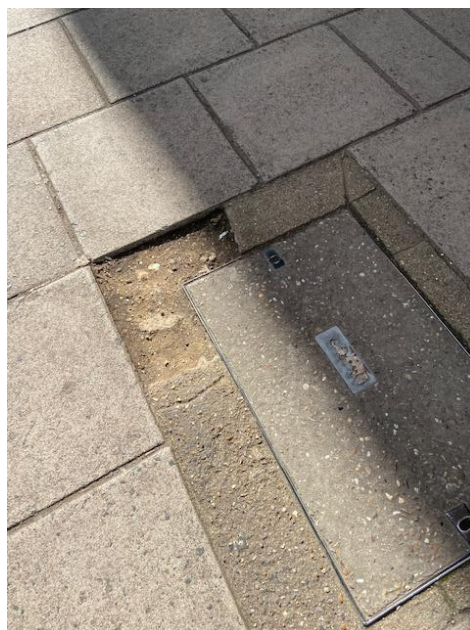
There are numerous inspection chamber covers which are surrounded with deteriorating cement or tarmac. If the cement deteriorates to the extent that it becomes detached (see picture right) it causes jolting to the wheelchair occupant, becomes a trip hazard for the carer, and can cause steering difficulties.

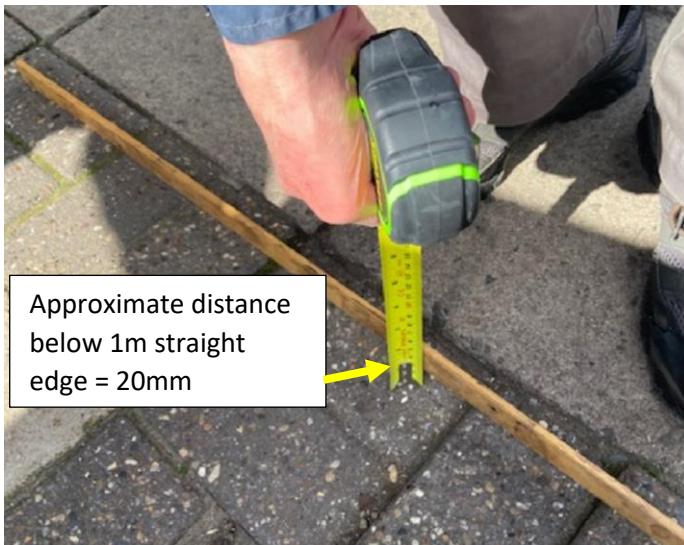
D3. Uneven, loose and cracked paving stones with joints frequently too wide.

Paving stones are often uneven. It is easy to find examples of sections of paving where the deviation of the footway surface under a 1 metre straight edge is of the order of 20mm or even more (see picture left). This is well in excess of the recommended 3mm.

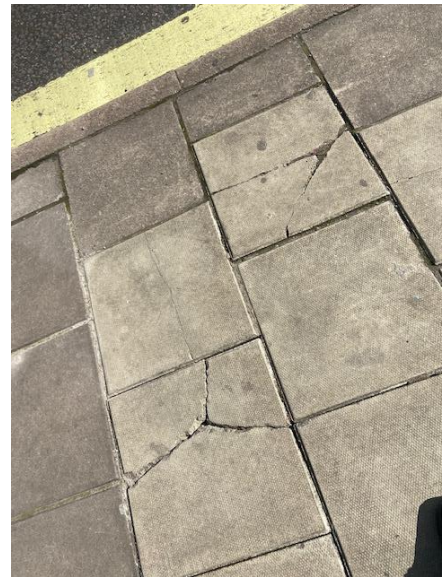
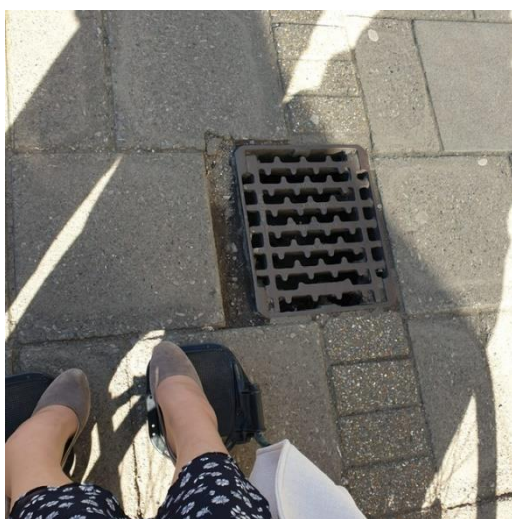
Damaged pavers such as those in the picture (right) are often associated with pavement parking (note the single yellow line) – they are clearly not intended to cope with the load. The resulting uneven surface provides multiple problems for the wheelchair user and attendant.

There are large gaps between pavers – sometimes of the order of 20mm or more in width and a similar depth – which should be filled with mortar. Where this is the case, sometimes the mortar is missing.

Where this is in the direction of travel, it is possible for a wheel to be trapped in the resulting gap. When at right angles to the direction of travel, it contributes to steering difficulties and potentially harmful vibration for the wheelchair occupant.

If gaps remain unfilled, water compromises the compacted base material. This can result in paving stones which rock, which ultimately leads to cracking.

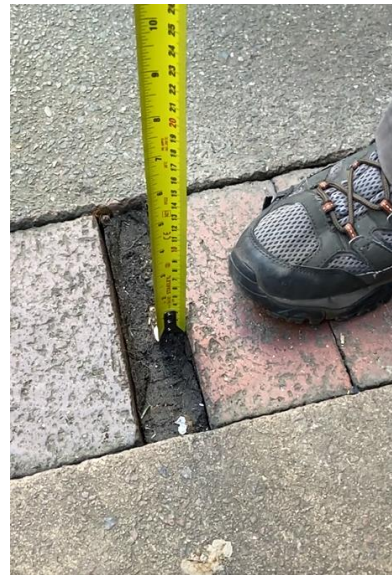
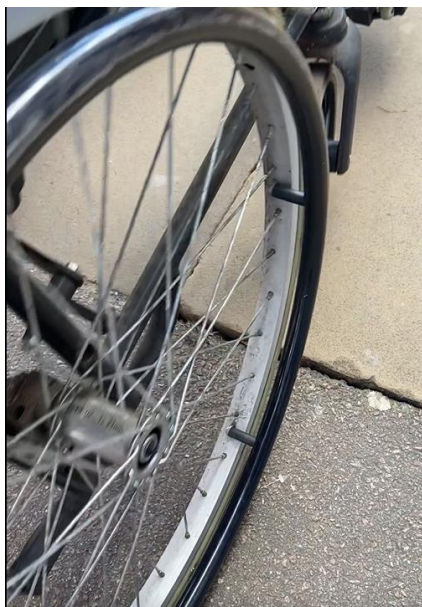
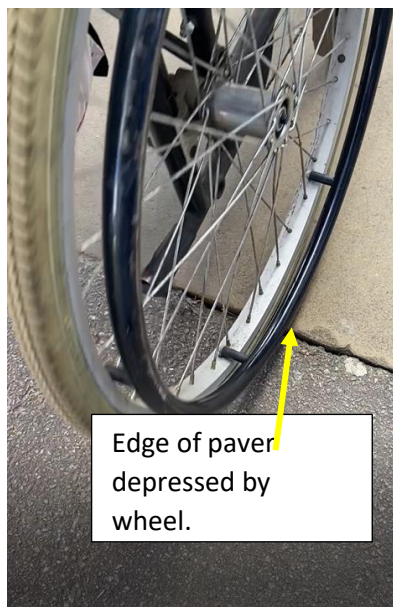
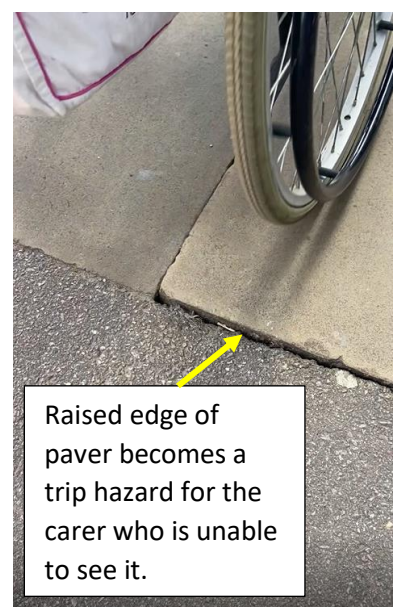
The worst examples of paving stones which rock can cause steering difficulties and/or be trip hazards for carers when they rock back up after the back wheels of the wheelchair have passed over it as in the sequence below.

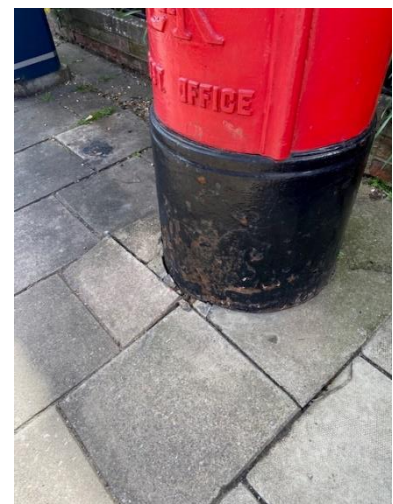
The worst example of damage to a paving stone is the surround to the letter box outside 3Es Accountants. Whilst not a particular hazard for the wheelchair user (it is well to the side of the walkway) it would be confusing for somebody with visual impairment using a stick.

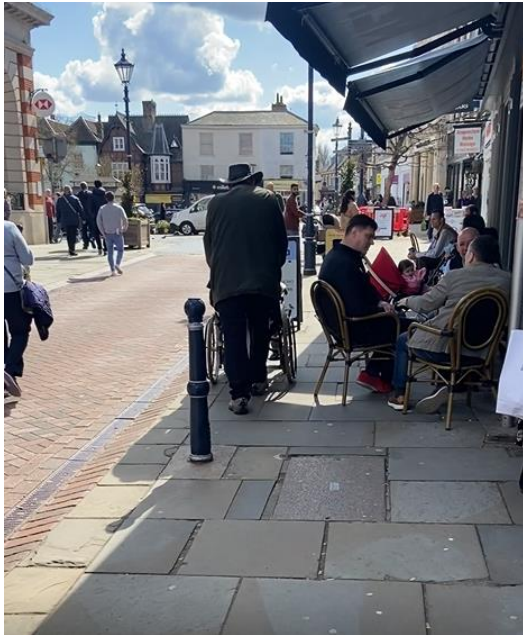
D5.Surface Obstacles

The most notable obstacles are outside seating for cafes, A boards and other street furniture. Pavement seating and tables outside Café Nero (picture left) effectively create a chicane, narrowing the usable pavement to such an extent that there is only just room for a wheelchair to pass unless the carer is prepared to allow the wheels to stray onto the sloping course of pavers which form the edge of the carriageway. This would be extremely uncomfortable for the occupant and would require an unusual degree of forearm strength to control. The carer also needs to manoeuvre around the fixed bollards which mark the pavement edge.

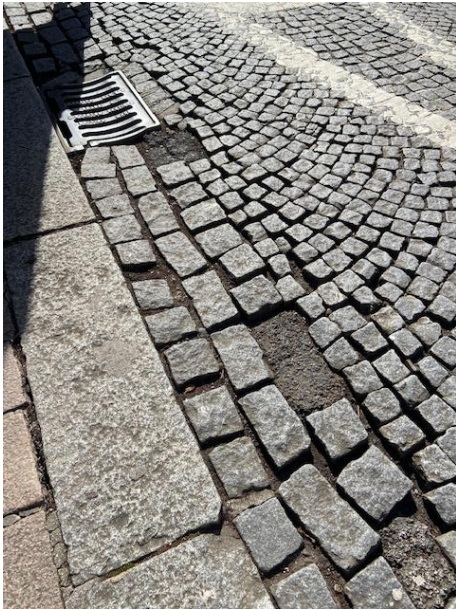
E. Market Square

The cobbles in Market Square are a feature against which there is strong advice in the official guidance. As shown in the picture (left) they are poorly maintained making for a surface which is extremely uneven with many gaps large enough that the front wheels of a wheelchair can easily be caught between them. At the very least, they cause considerable potentially harmful vibration for both wheelchair occupant and carer.

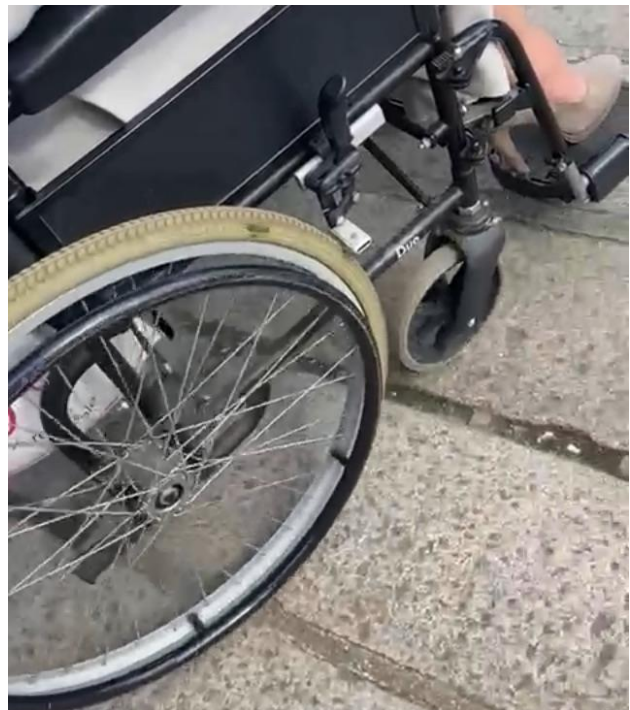
The larger pavers (right) are intended to make it possible to cross the square without having to use the cobbles. Having tried pushing the wheelchair, I can say that even the pavers are sufficiently uneven to generate an uncomfortable level of vibration for both occupant and carer. On the day of this informal survey, it was noted that some of the seating and gazebos were situated on these pavers and a group of motorcyclists had parked their bikes on the ones at the southeast corner of the Square. Whilst it was possible to circumnavigate these obstacles, Adrian assured me that this becomes much more difficult on days when there are more gazebos or activities taking place.

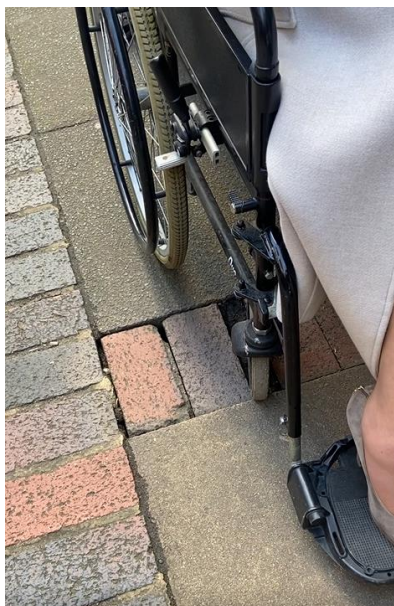
F. Churchgate

Generally the surface conditions are relatively smooth, but there is at least one dangerous gap between pavers where the mortar is missing. A few days before our survey, Sharon was nearly tipped out of the chair when the wheel became lodged in the gap (picture left) and Adrian suffered painful bruising.
